Trouble Shooting List				
No.	Subject	Model	System	Remark
1	Intermittent engine check lamp on / engine hesitation	DI All	D27DTP	
2	Cooling Fan Noise at Cold Start	RV All	DI Engine	
3	DI Engine Cylinder Head Gasket Leakage	Actyon	D20DT	
4	Turbo Charger Whistle Noise at Accelerating	Actyon	D20DT	
5	REXTON II CDPF EGT Sensor Removal/Installation	Rexton II	D27DTP	
6	Engine Hesitation after First Delivery	RV All	EURO IV Engine	
7	Rework Procedure for DI Engine Oil Pan Leak	C/D/Q-Car	D20DT	
8	Troubleshooting for DI Engine Alternator Noise	RV All	DI Engine	
9	Installation Notice for Air Cleaner Assembly	C/D/Q-Car	D20DT	
10	Modification of DI Fuel Tank Vent. Tube	C/D/Q-Car	D20DT	
11	DI Engine Cylinder Head Cover Gasket Leakage	Y/C/D/Q	Engine	
12	E-EGR & Throttle Body Initialization	RV All	EURO IV Engine	
13	Engine Noise Come inside Vehicle	A/Sports	D20DT	
14	Engine Power Lack at Accelerating	C/D-Car	D20DT	
15	Engine Check Lamp ON caused by HID Modification	Rexton II	D27DT

Intermittent Engine Check Lamp On & Engine Hesitation

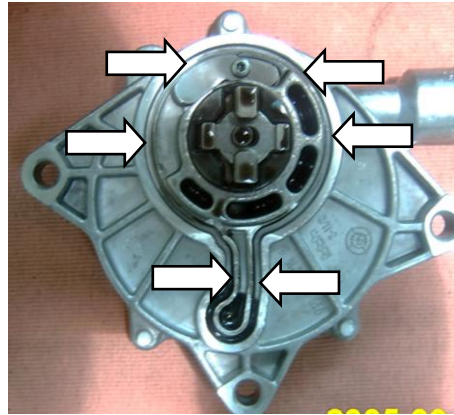
4. Check vacuum pump internal roughness

- Do not reuse vacuum pump o-ring, replace with new one
- Clean the oil contamination on cylinder head gasket and cylinder block using cleaner
- Keep the tightening torque of cylinder head camshaft cap (#12, for vacuum pump area)

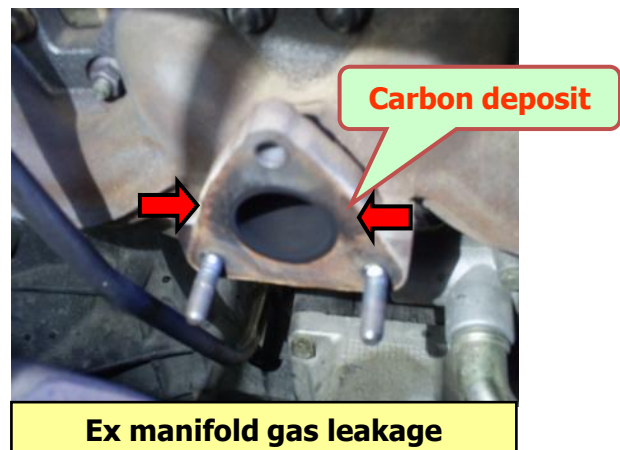
Turbo charger noise caused by gas leakage from turbo charger mounting area and loosened exhaust manifold

*In case of turbo charger noise, check the gas leaking from exhaust mounting area first
(Do not replace turbo charger without checking gas leakage)*

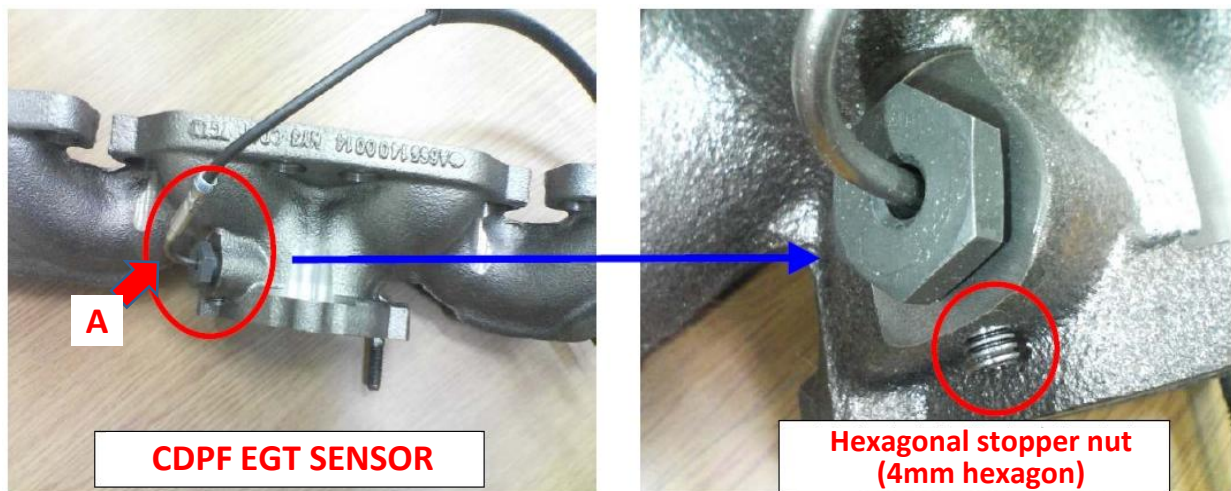
- If the stopper bolt doesn't be removed, EGT sensor's bitch can be damaged
- Take care not to be damaged bending area (A) of EGT sensor while installation by wrench
- Keep the tightening torque

1. Loosen the hexagonal stopper bolt (4mm)
2. Remove the EGT Sensor

Tightening Specification : 45 ± 4.5 Nm

※ To prevent EGT Sensor loosening, lock-up using stopper bolt

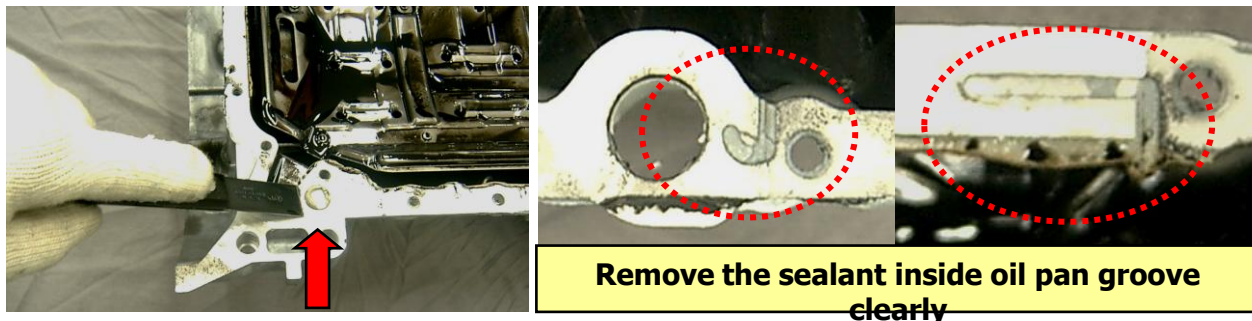
Recently SYMC has been reported field claim of engine oil fan replace on D20DT engine caused by oil leak
Especially, oil leak from lower area of alternator

- 1) Disassemble front axle assy for 4WD model. (don't need to disassembly front model for 2WD model)
- 2) Remove engine oil fan for enough work space
- 3) Clean up remaining sealant using scraper or brush (clean up cylinder block side as well)
(Take care remaining material do not go engine oil pan inside)

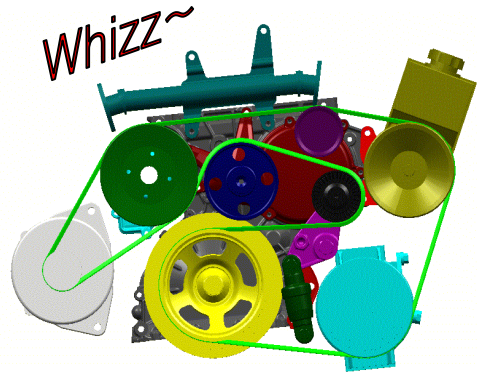
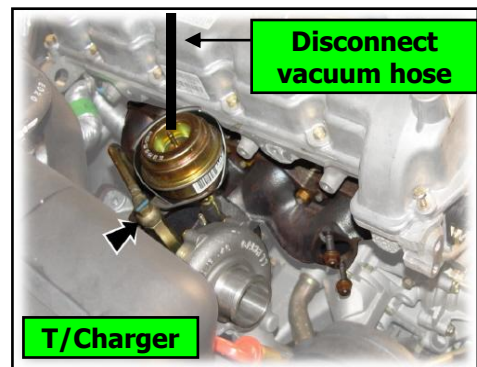
- Turbo charger whistle noise (wind noise) from engine front side at idle and at engine acceleration condition (between 1,200 ~ 1,800 RPM) like turbo charger sound.
- Noise is gone when vacuum hose of turbo actuator is disconnected

This is turbo charger normal operation sound
; VGT air boosting sound and passing sound of exhaust gas

- . VGT type turbo charger used on Actyon / Actyon sports / Kyron/Rexton II models, vane inside turbo charger is widen at accelerating and it increase input air volume very quickly
- . In this time, turbo charger makes whistle noise (whizz~)
→ Normal operating sound

in case of D20DT engine, check the sound after disconnecting vacuum hose for turbo charger.
If there is no sound, **DO NO REPLACE ALTERNATOR**
(VGT turbo charger operating sound)

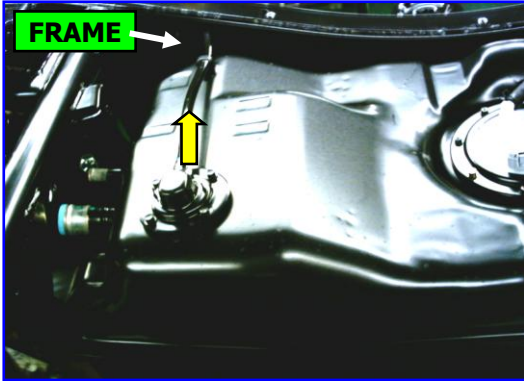
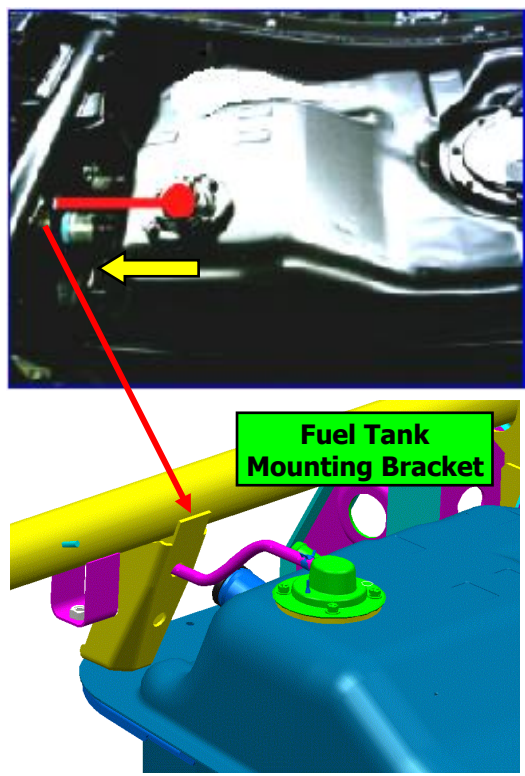
ITEM	BEFORE	AFTER
Changes	<ul style="list-style-type: none"> - Ventilation hose is connected to right side of frame (refer to below photo) 	<ul style="list-style-type: none"> - Rotate ventilation hose 90 ° and make connection to mounting bracket for fuel tank - Change hose size (370 → 165 mm) & delete mounting clip
Photos

<p>* Insert the ventilation hose into upper hole of fuel tank mounting bracket</p>
Parts Info.	<ul style="list-style-type: none"> - Fuel Tank Assy : 2211009404 - Ventilation Tube : 2218009401 	<ul style="list-style-type: none"> - Fuel Tank Assy : 2211009405 - Ventilation Tube : 2218009402

- If you use new type fuel tank assy in steady of old type fuel tank, you should replace ventilation tube with new type (part no. **22180009402**) at the same time
- SYMC do not allow any modification for fuel system, please don't make any changed to rework
 - . Don't cut off ventilation tube for voluntary modification
 - . Other voluntary modification

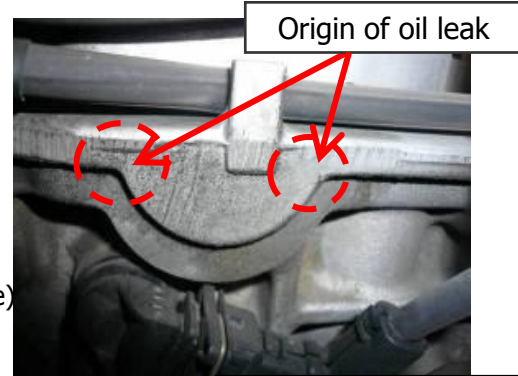
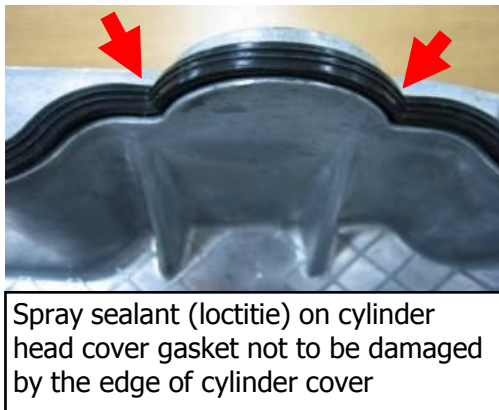
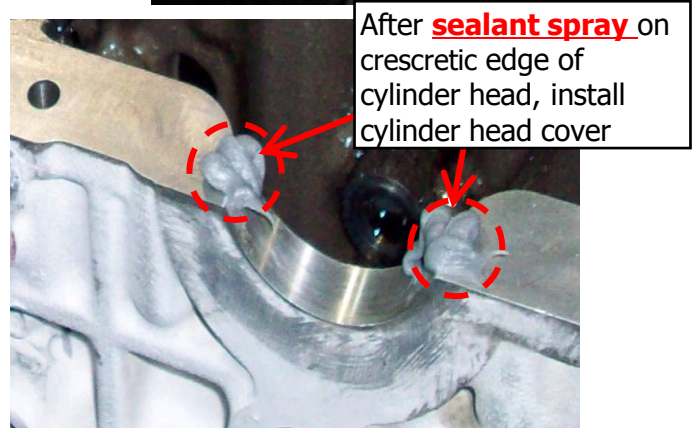
Oil leakage from cylinder head cover

Remove the cylinder head cover and then spray sealant (loctite) on crescentic seal

- Spray a small sealant (loctite) and take care not to flow inside engine
- Do not replace cylinder head cover by this reason
- RECHECK OIL LEAKAGE USING CERTAIN DEVELOPER

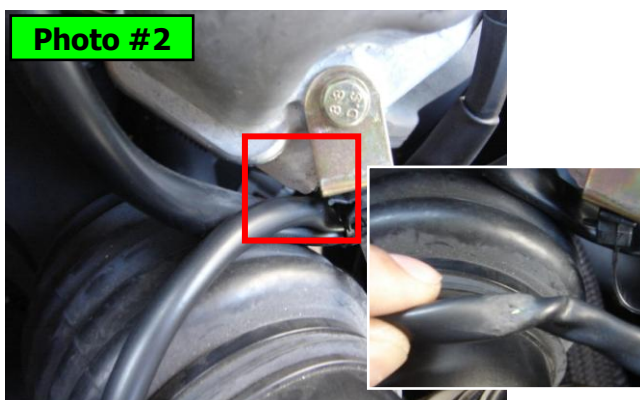
Short circuit at accelerating

Wiring damage caused by engine running movement

- Same symptom could be happened when HFM sensor disconnected, at this time ECU substitute intake air value as internal MAP data and decide engine power
(substitution : change from 420 to 800 according to engine RPM)
- In case of wiring damage, there is large variation on the value for intake air volume
(5 ~ 1,000 m/stk)

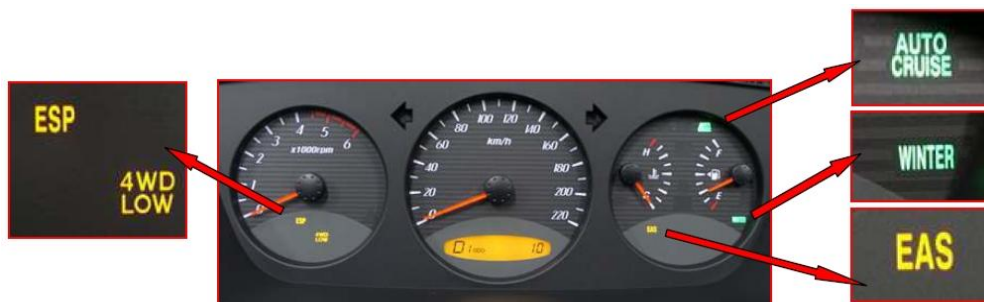
Unstable power source caused by HID modification
 (Symptom happens when head lamps turn ON)

- 1) cluster warning lamps turns ON when head lamp auto ON at Auto mode or turn on head lamp switch
 - ESP warning lamp ON (on the vehicle without ESP option)
 - 4WD check, 4 Low lamp ON (on 2WD model)
 - Auto cruise ON (on the vehicle without Auto Cruise option)
 - POWER lamp ON (regardless of operation of WINTER/POWER switch)
- 2) A/T LHM (gear holding) caused by CAN system error
- 3) Malfunction on electric units

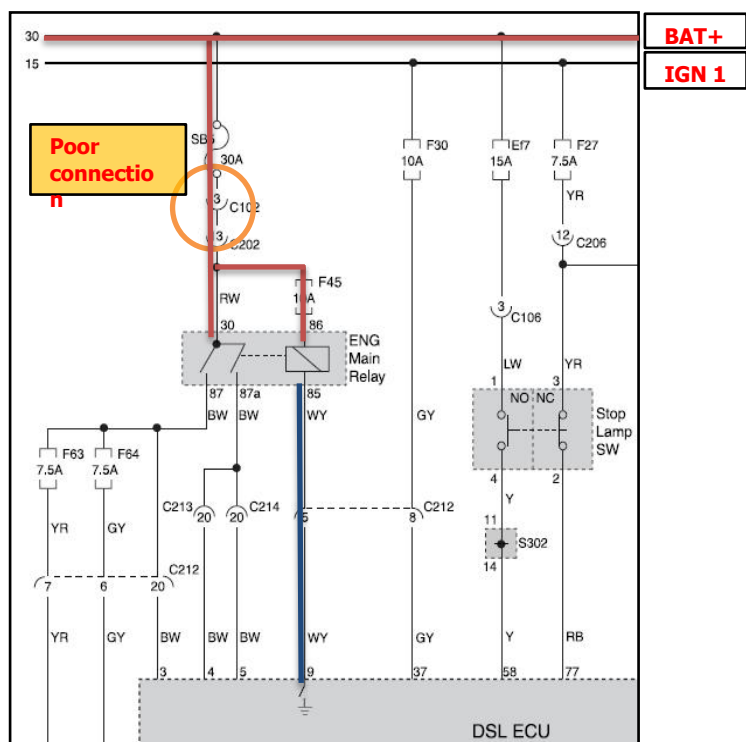
Engine intermittent not start caused by poor connection of C102 in engine room fuse box

1. Check all related fuses and relays
2. Check battery output (12 v) at engine main relay Pin 30 and Pin 86
 - If battery power doesn't check, check B+ is transferred through C102 Pin #3 and C202 Pin #13
3. At IG ON, check ECU Pin #9 is grounded
 - At IG ON condition, engine main relay operates and battery power is transferred to ECU through Pin #87 and Pin #87a

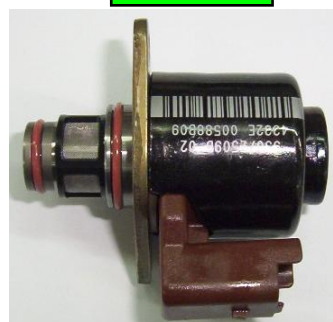
- Function : Control the rail pressure by regulating the amount of fuel which is sent to the pumping element of HP Pump
- Operation : ECU increase current flow when rail pressure is higher than demand. Piston of IMV close orifice and block fuel flow

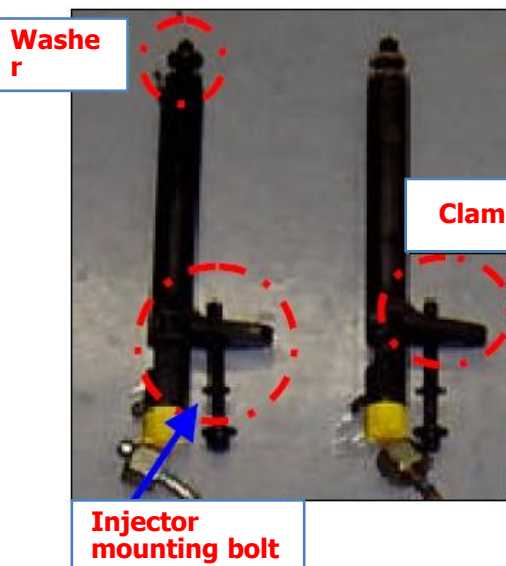
- In case of Injector mounting bolt reuse, engine compression pressure could leak by mounting bolt deformation

- Injector bolt (M6*60) should be replaced with new one whenever Injector is removed

* Injector Bolt (M6*60), P/No. : 665 990 02 01

Tightening torque : 10 Nm + 180 °

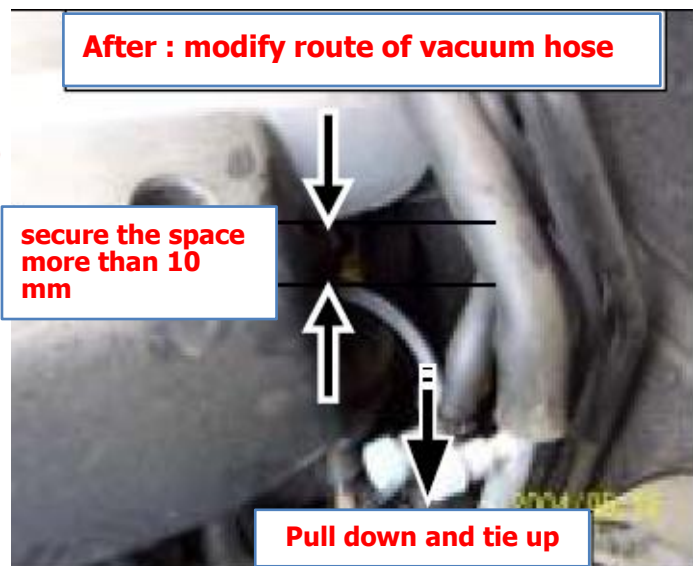
- Vacuum Hose for 4WD locking hub damage by interference with engine acoustic cover
→ EGR out of control by vacuum leakage
- ※ In case of vacuum leak, it effect EGR valve operation firstly

- ▶ In case of P0400 on Rexton D27DT model, check vacuum hose interference and modify hose route if necessary
→ Pull down vacuum hose a little bit and tie up with neighborhood pipe (keep some space from engine acoustic cover)

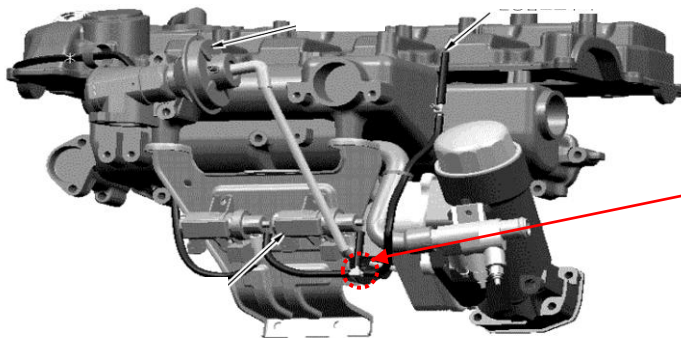
- Check EGR vacuum pressure using vacuum gauge

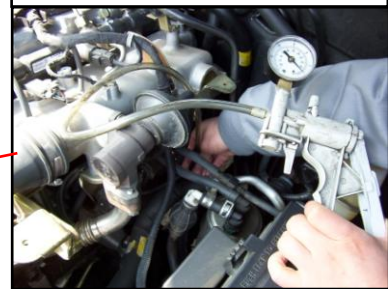
Vacuum test from the EGR modulator

Normal : -0.9 ± 0.02 bar

- Vacuum leak : less than -0.5 bar

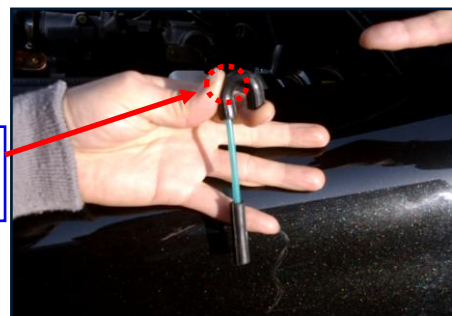
**vacuum leak
by hose**

- Found 4WD solenoid valve vacuum hose crack
- Replace damaged vacuum hose

Do not replace EGR vacuum modulator without inspection, should check vacuum pressure and find actual reason of problem correctly

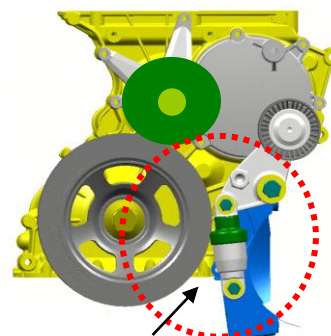
Belt Tensioner

On the investigation of replaced belt tensioner, SYMC figured out the it was replaced by mis-diagnosis. Please check belt tension according to this instruction guide and DO NOT REPLACE BELT TENSIONER DUE TO OIL CONTAMINATION

1. Remove the fan belt
2. Spray WD40 around contaminated area
3. Wait around 5 minutes
4. Blow the contamination away using compression air
; Take care not to direct contact compression air into rubber part of belt tensioner
5. Clean up the rubber part with clean cloth
6. Install the fan belt

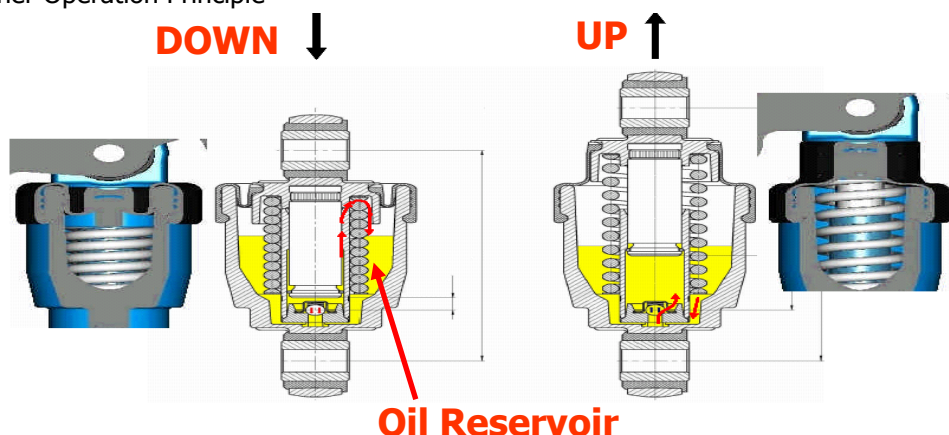
Expansion Stage (UP) : Oil flow into the Piston through check valve

Compression Stage (DOWN) : Oil flow out though oil gap of piston upper to oil reservoir

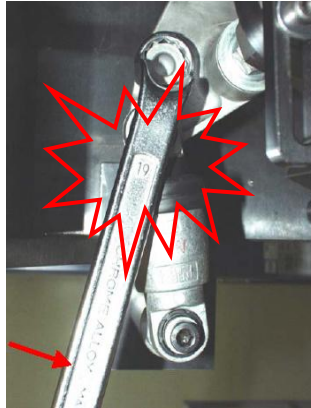
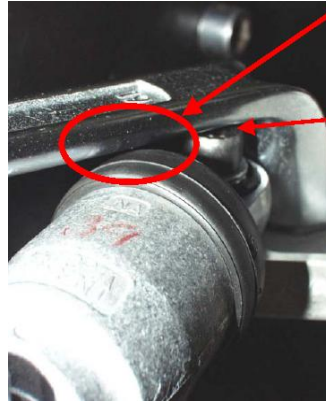
**Special attention
to interference
using the wrench**

Take care not to damage the rubber bellow of belt tensioner while removal and installation of fan belt using wrench

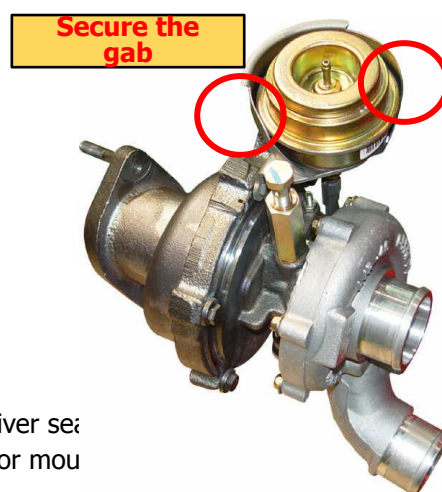
- This noise seems to come from EGR valve side if you seated at driver seat
- In case of poor installation of air clear housing (gab caused by poor mou there could be similar whistle noise

- **Symptom** : Wind noise from engine front side (intake manifold) at accelerating (over 1,500 RPM) caused by air cleaning housing leak due to poor workmanship while air cleaner replacement
- **Repair History** : No result after replacing Tharger, EGR valve and Vacuum Modulator several times
- **Possible Causes** : Unexpected air input casused by air cleaner housing leak
- **Troubleshooting** : Reinstall air cleaner housing (housing bolt tightening torque : 4.2 ~ 6.2 Nm)

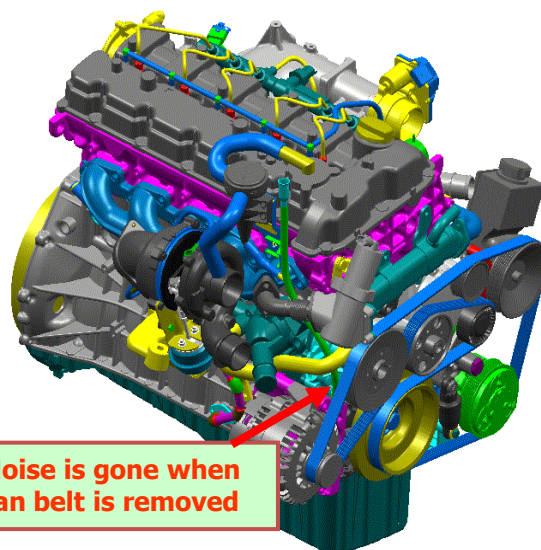
- Whistle noise (beep sound) from engine front side at accelerating at the vehicle speed of 40-50 km/h (between 1,000 ~ 2,000 RPM) like turbo charger noise
- Noise can be heard at engine stall test (around 1,800 RPM)
- Noise is severe at cold engine than hot engine
- Normal (no noise) at engine idle condition
- **Noise is gone when fan belt is removed**

Noise is gone when fan belt is removed

- Check whether noise is disappeared after removing engine fan belt, EGR valve one by one
- Also should check clamps and bolts of IN/EX hose

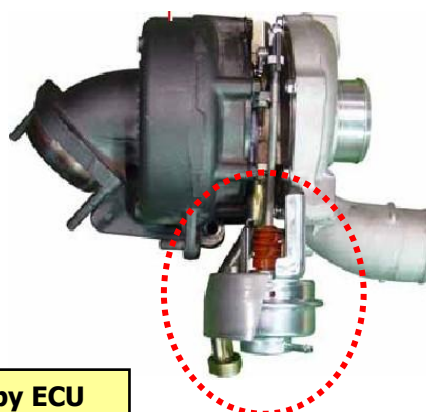
*** Vane control actuator**

At accelerating over 1,000 RPM, there is whistle sound
It means that turbo charger works normally.
Also, at releasing accel. Pedal (tip-out) suddenly, there would be exhaust harsh sound such as "shriring ~"
and sound level will be different according to vehicle variation, road condition and engine temp.
(Before engine warm-up, sound level could be bigger than hot engine condition)

Point : Turbo Charger on D27DTP engine is controlled by ECU PWM signal according to combustion condition, engine temperature and so on. This lead to a little bit different sound tone at turbo charger operating

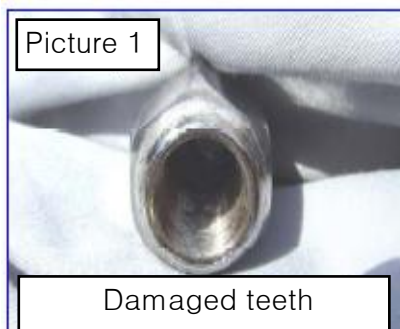
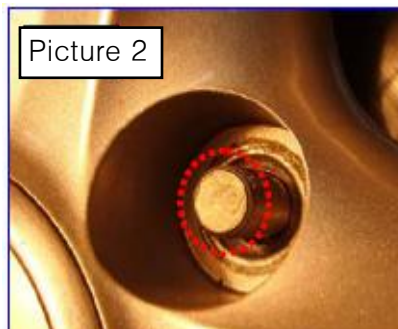
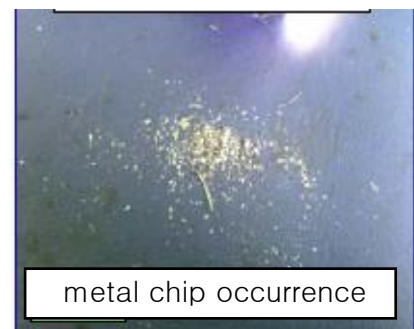
Mounting Bolt and Nut damaged due to inflow inside of bolt/nut when removing and installing tire wheel nut

Remove metal chip completely before installing Tire wheel Nut

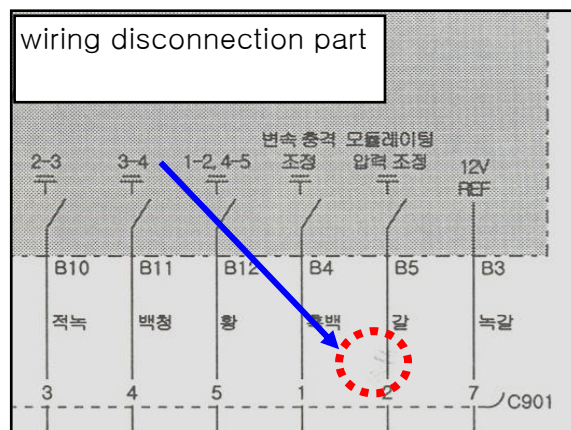
Resistance value of A/T solenoid valve can be changed highly according to A/T inner part temperature

* Check fully beforehand, because You can misjudge "A/T inside defect" above phenomenon

Firstly measure resistance in TCU side, and then Measure C901 connector

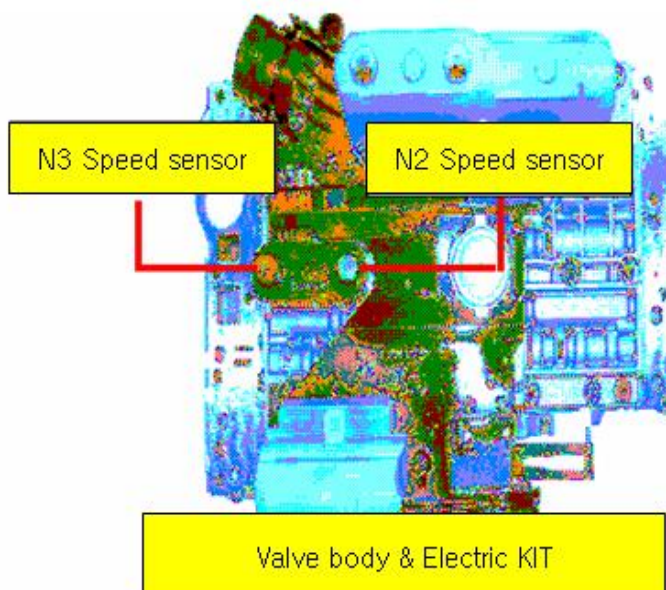
N2 Speed sensor senses the speed of carrier of front carrier gear

1. Check A/T Oil quantity
 2. Check wiring contract condition between TCU and N2, N3 sensor
(Check C901 connector↔Adaptor, Check Plug↔Electric Kit wiring)
 3. Check dust powder on N2,N3 sensor after removing valve body
 4. Remove and Clean Foreign particular foreign particular on N2,N3 sensor of Electric KIT, and then install valve body, and then check normal operation
- ** In that case foreign material attached on N2,N3 sensor is magnetism, It may cause Sensor malfunction
- ** If necessary, replace mission filter

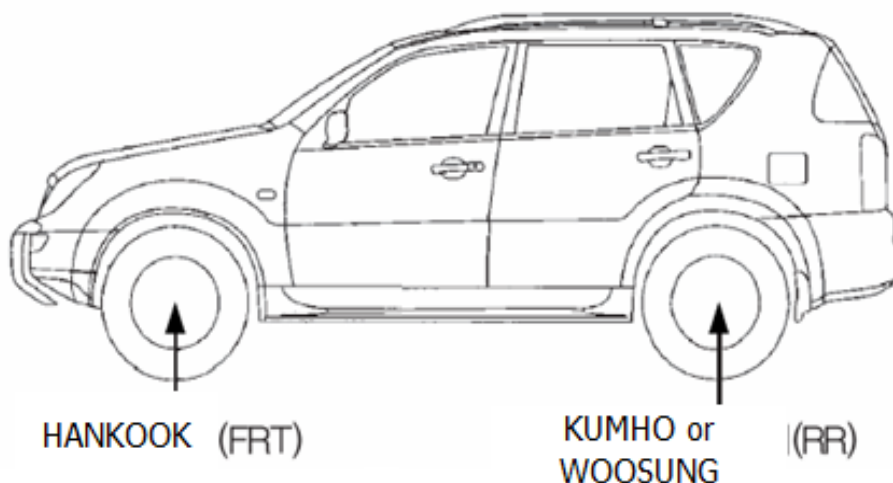
In that case 4WD vehicle,
power train can be damaged while high speed driving because it is impossible to absorb front/rear speed or rotation difference

Conversion is delayed due to occurrence Wind up Phenomenon of power train system of transfer case or auto locking hub when changing to 2wd again

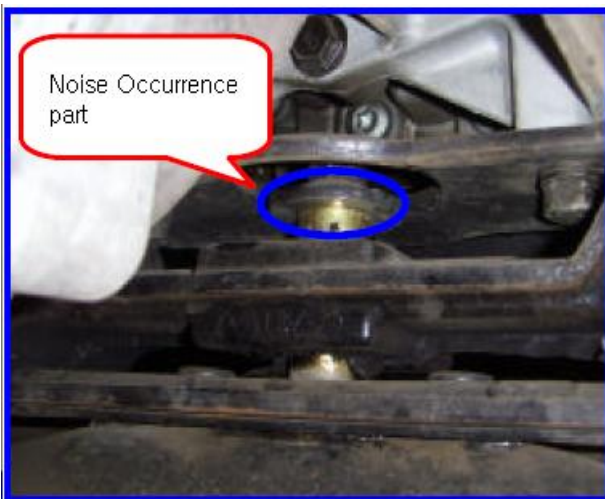
Washer specification: $\Phi 14.5$ Plain washer

Interference noise between steel tube and washer

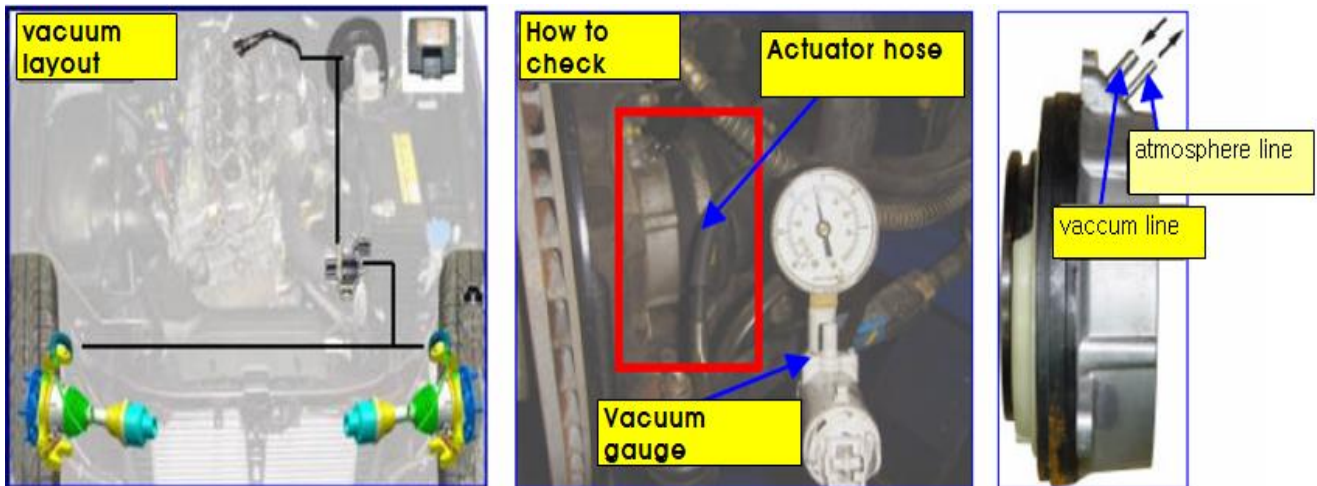
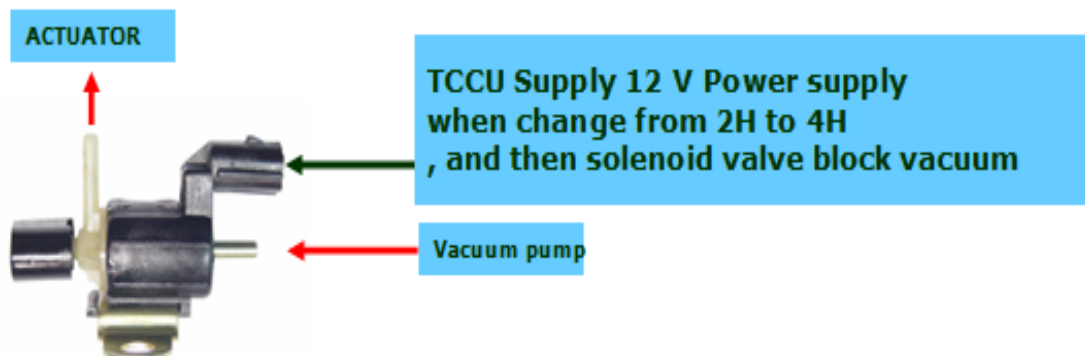
Vacuum leakage

- 1)stop the engine While 2wd mode, and then remove front left and right tire
Remove hose connected in locking hub actuator
- 2)Check if vacuum is made with vacuum gauge
(Normal if vacuum keep up approx 30 second)
- 3)Check also if vacuum is maintained in locking hub actuator with vacuum gauge
※If minute leakage occurred, it may cause clink noise due to poor 4WD engage

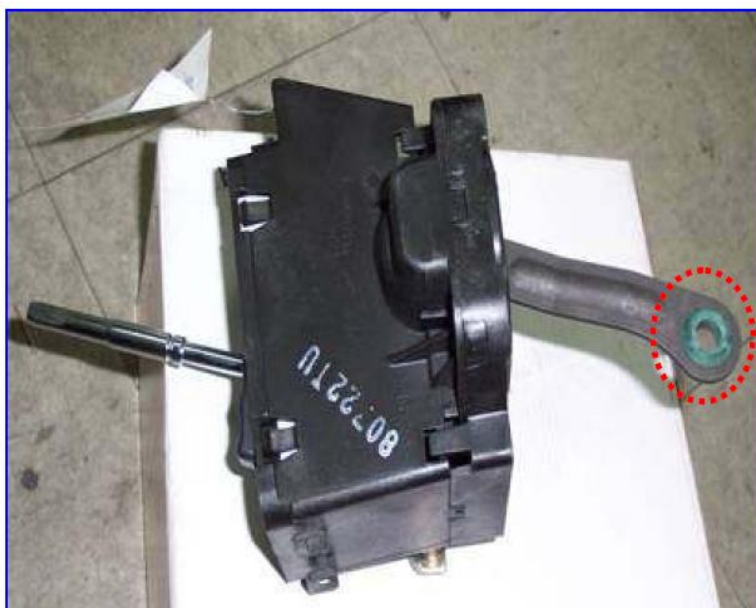
< TGS LEVER ASS'Y >

Noise occurrence while driving due to TGS lever bearing wear
Especially occurrence at that time Mileage 50,000 ~ 60,000 km

TGS lever bearing wear

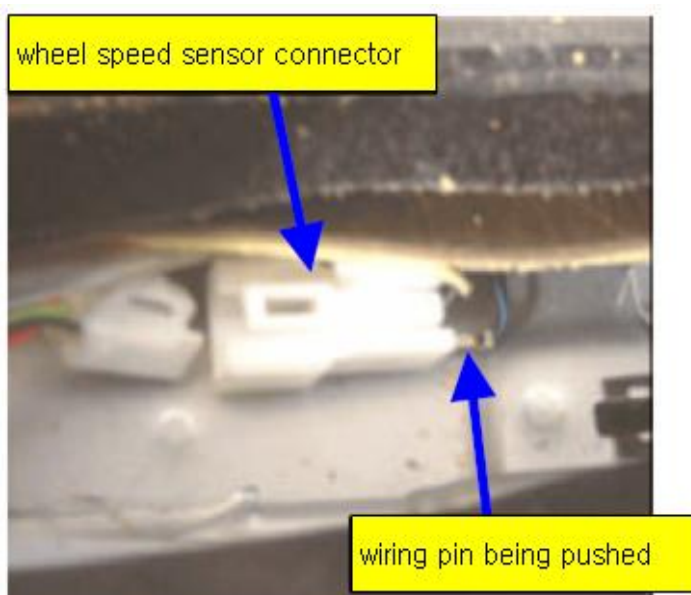
- If Wheel speed sensor equipped at RR RH wheel occurred vehicle speed error,
"speed meter of Instrument cluster not operating and Limp Home Mode go into
(Refer : Vehicle not equipped with ABS can not possible to diagnose with scan-100)

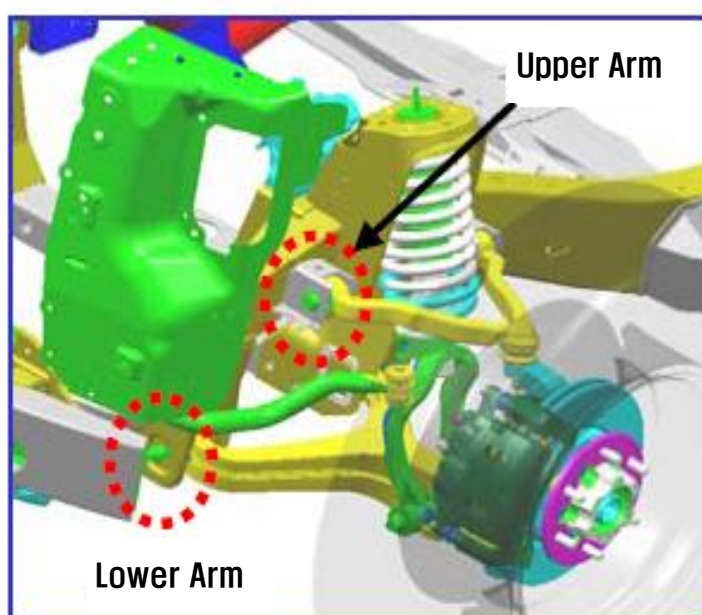
Loosen Tightening Torque

When tightening chassis part mounting bolt & nut, Tighten with specified torque with torque wrench surely

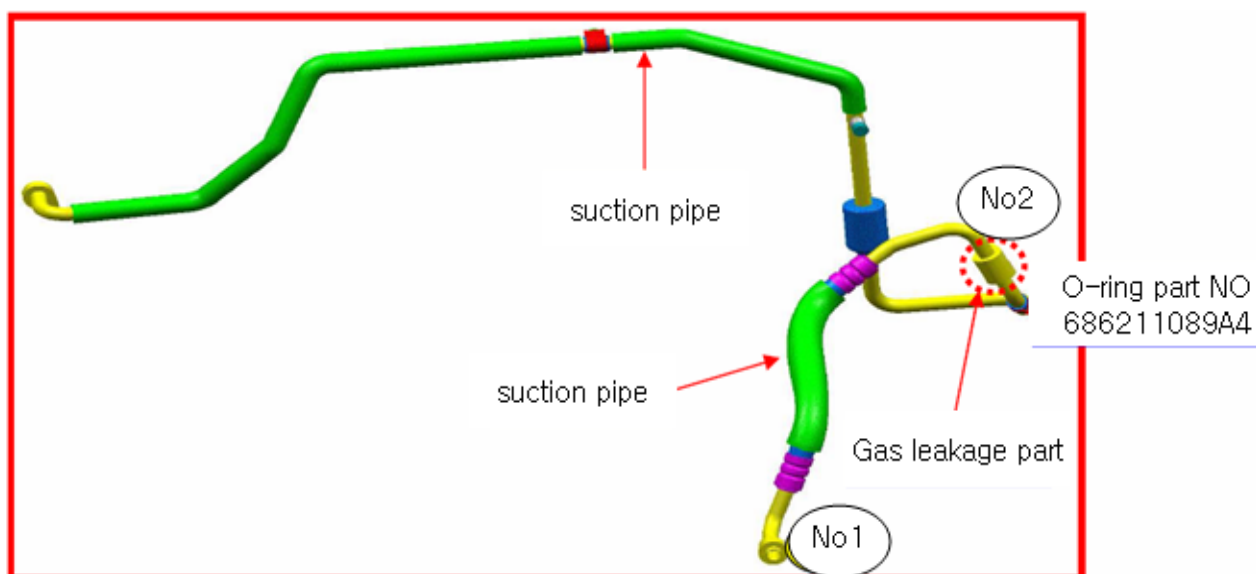
Air con Gas leakage at Air con suction hose & suction pipe

- 1) Check if O-ring damaged after loosening No 2 Nut (10mm), If damaged, Replace O ring
- 2) Loosen No 1
- 3) Assemble No 1 After assembling No 2 Nut(10mm)

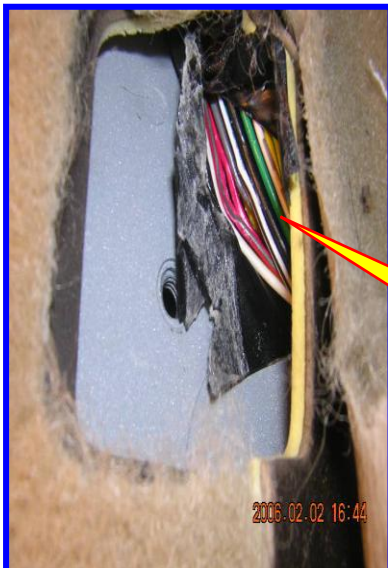
"D" holding due to short circuit occurrence between B7 and

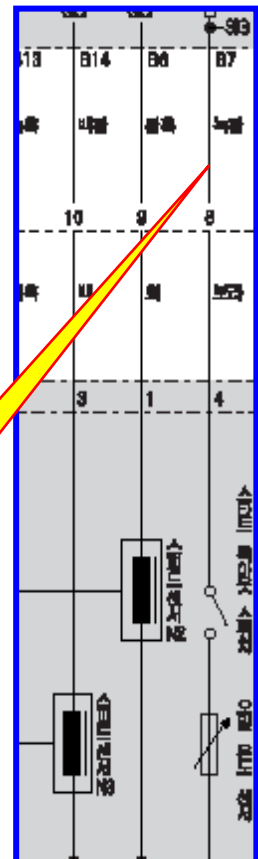
Wiring short circuit occurrence

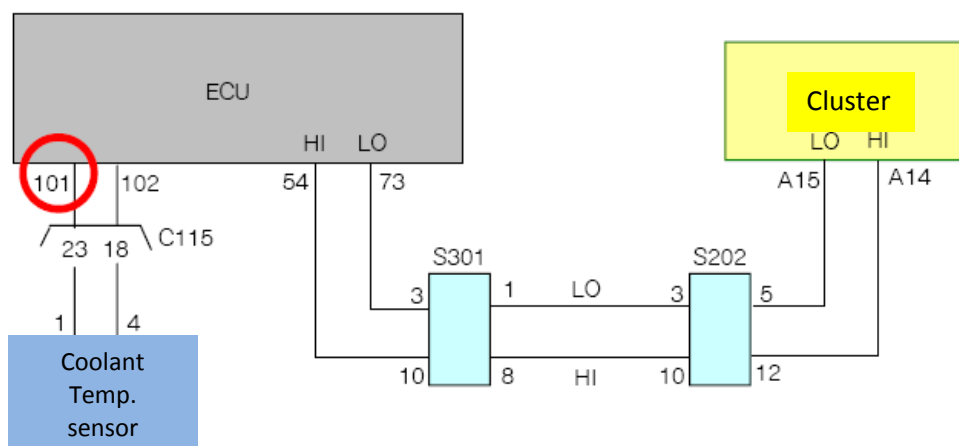
► EWD for Actyon D20DT

Coolant temp. sensor check by resistance
Wiring connection between coolant temp. sensor and ECU
Connector check by eyes : C115, ECU connector terminals
ECU Pin #101 was defectively connected : Intermittent connection failure

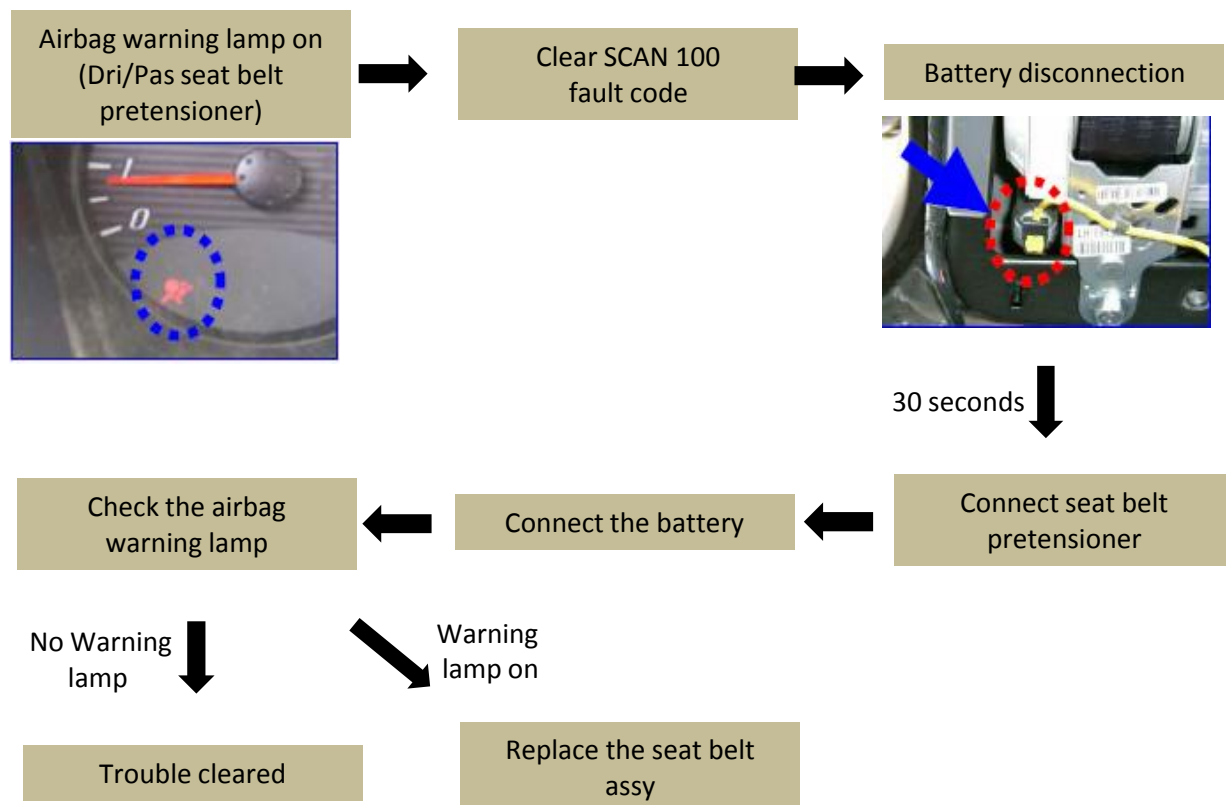
- Vehicle static electricity by occasion caused seat belt pretensioner resistance error

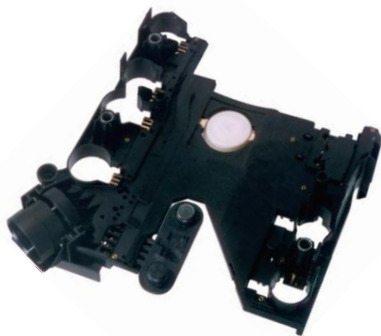
<P/No : 20327 00089>

- Connection damaged by exterior vibration
- 7mm nut was stuck by high temperature

- Check the electric circuit (Solenoid, Wiring from TCU to plug connector)
- Replace the electric kit
